DIVISION Power Systems  
TM 7972:70-640  
DATE 25 August 1970  
W.O. 1475-78-2000

**TECHNICAL MEMORANDUM**

TITLE: Evaluation of SNAP 8 Bare Refractory Double Containment Boiler No. 2  
After 8700 Hours of Operation

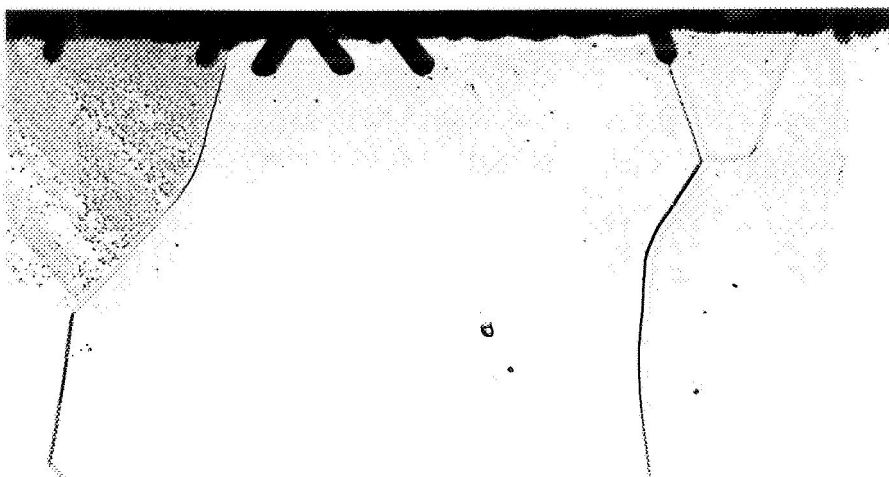
corrosion of the Ta was detected by metallographic examination of various sections from the Hg inlet to the outlet end of the boiler. In the plug section, the tube I.D. was expanded in the areas where it had been swaged over the lands of the plug, Figure 5. Intimate contact between the tube and the plug lands had been achieved by the swaging operation and maintained through the 8700 hours of operation of this boiler verifying the suitability of the inlet plug section fabrication procedure.

Sections of the multi-passage Ta plug from the inlet end and from the Hg outlet end were examined metallographically. The sections were identical metallographically. The Ta was in the recrystallized condition, but the swaging operation had upset the lands producing some mushrooming effect, Figure 5. The land machining marks were still visible on the sides of the lands and at the base of the grooves there was some roughening presumably due to the machining operation. Microhardness traverses indicated the swaging had produced some work hardening of the lands. The hardness of the flutes decreased from the top of the lands toward the center of the plug. The hardness showed a variation between lands indicating that the cold work during swaging was not completely uniform. At sporadic and isolated locations some particles up to 0.00017 inches thick were present in the grooves. This material may have been mass transfer products but there was insufficient material present for analysis. It did not appear that Hg corrosion had occurred and no indications of potential plug failure were detected.

Figure 5 - Transverse section through Ta tube and plug at Hg inlet.

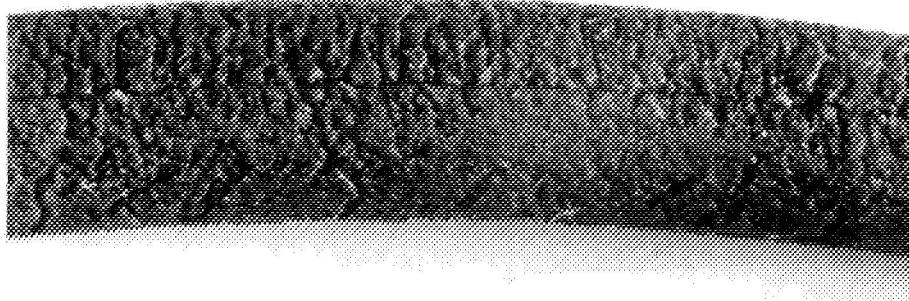
The area below the weld where the tube had been rolled into the header appeared satisfactory from a metallurgical standpoint, Figure 19. No evidence of incipient failure or other deleterious effects were observed. Although the rolled area appeared to provide some support of the tube by the header, there was not intimate contact along the entire rolled area between the tube and the header.

Figure 19 - Configuration of Ta tube where it was rolled into the Hg outlet header during boiler fabrication.

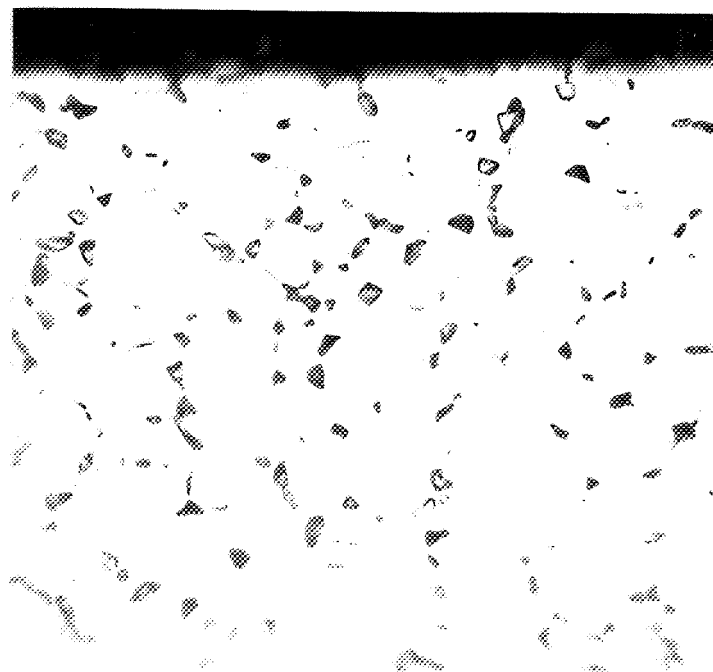
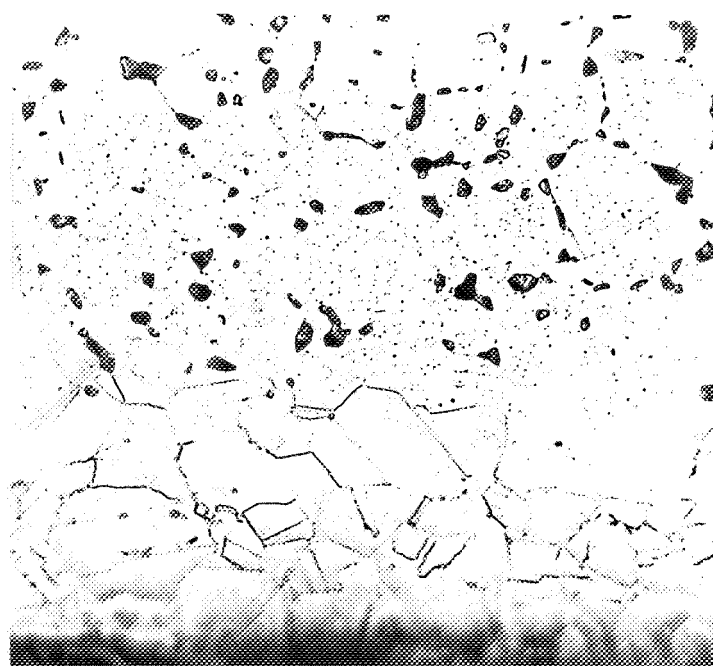
NaK corrosion was not detected on the I.D. of the shell material at either the inlet or outlet ends. However, mass transfer products up to 0.003" thick were present at the NaK outlet end, Figure 23. These products are the result of corrosion in the high temperature portion of the PCS-1 system. Presumably this corrosion occurred primarily in the gas-fired heater tubing used to simulate the reactor in the PCS-1 testing. Ultrasonic wall thickness determinations indicate the 316SS heater tubing wall has thinned an average of 0.0008 inches per 1000 hours of operation. Due to the non-isothermal nature of the system, the corrosion occurs at the highest temperature portion of the system and deposition occurs at the coldest areas of the system when due to the lower NaK temperature, the solubility of elements in solution decreases and precipitation occurs.

Figure 23 - Section through 316SS boiler shell at primary NaK outlet showing mass transfer deposition I.D. and absence of sigma phase in structure.
